APPENDIX G.4

618-10 BURIAL GROUND AND 316-4 WASTE SITE (RC-LS-4, RIVER CORRIDOR) EVALUATION UNIT SUMMARY TEMPLATE

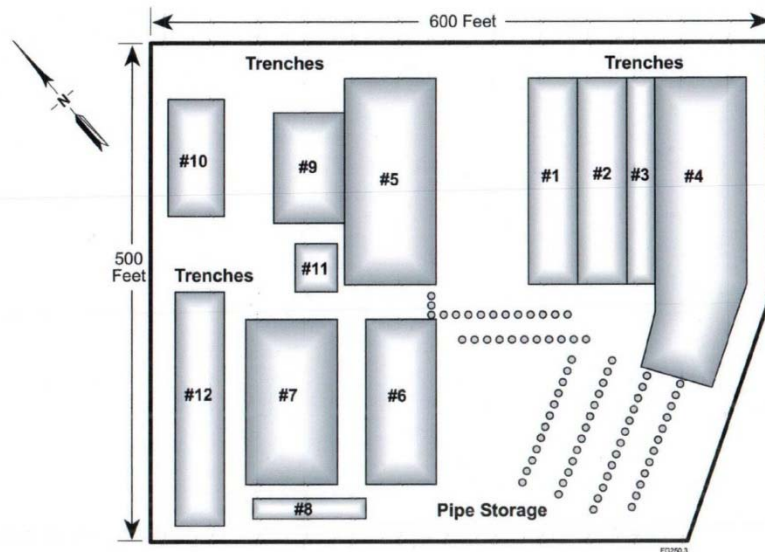
Figure G.4-1. Schematic of the 618-10 Burial Ground Trenches and VPUs

The 618-10 burial site is an inactive disposal site containing hazardous and radioactive waste from the 300 Area. The site operated from March 1954 to March 1962 and from October 1962 to September 1963. It reopened in 1962 to support waste-disposal activities while vertical pipe units (VPUs) were installed in the 618-11 Burial Ground and closed for the final time after the 618-11 Burial Ground was operational. The 618-10 site consists of 12 trenches and 94 VPUs (see Figure 1, Schematic of site).

The trenches are of various sizes of up to 75 ft. wide and 301 ft. long. They were believed to be 20-25 feet in depth but excavations to date have found they exceeded 30 ft. in some locations. Historical records indicated that 2,255 drums were buried in the trenches (972 concrete, 178 DU black oxide, 537 DU chips/turnings, 47 Zirconium, 40 Thorium and 480 miscellaneous). The concreted drums were generated from the disposal of waste in the 300 Area laboratories. Waste was generally loaded into an 8-in. diameter culvert placed in the center of a 55-gal drum. The culvert was capped with a lead plug and the drum was then filled with concrete. Waste disposed in concrete drums included high activity waste and plutonium-contaminated liquid. Some of these drums also had up to 2 in. of lead shielding. Black uranium oxide was generated by the thermal treatment of uranium mill turnings to form an oxide. Incomplete oxidation of the uranium presents a significant handling risk. Uranium chips that have not completely oxidized can ignite when exposed to the atmosphere. Uranium and zirconium metal turnings were generated from fuel element fabrication. Both are pyrophoric and present an airborne exposure risk should they become ignited. Typically, uranium and zirconium turnings were packaged in 30-gal drums. For stabilization, the uranium turnings were immersed in cutting oil often containing polychlorinated biphenyls (PCBs). The zirconium chips were packaged in a water/oil mixture before disposal. Other waste disposed in the trenches includes bottles, shipping casks (i.e., transportation pigs), gloveboxes, hot cells, tank, processing equipment, and metallurgical samples of spent fuel. Radiological and chemical hazards include, but are not limited to, cesium, strontium, plutonium, americium, neptunium, uranium, beryllium, lead, zirconium, and deactivated sodium-potassium metals. Historical information is limited on the bottles sent to this burial ground. The bottles were suspected of containing
